Technical Note

January 1986

By Spencer R. Conklin,
Daniel A. Zarate,
and Robert L. Alumbaugh
Sponsored by
Naval Facilities
Engineering Command

Experimental Polyurethane Foam (PUF) Roofing Systems- III: Naval Station, Roosevelt Roads, Puerto Rico, and Naval Facility, Cape Hatteras, North Carolina

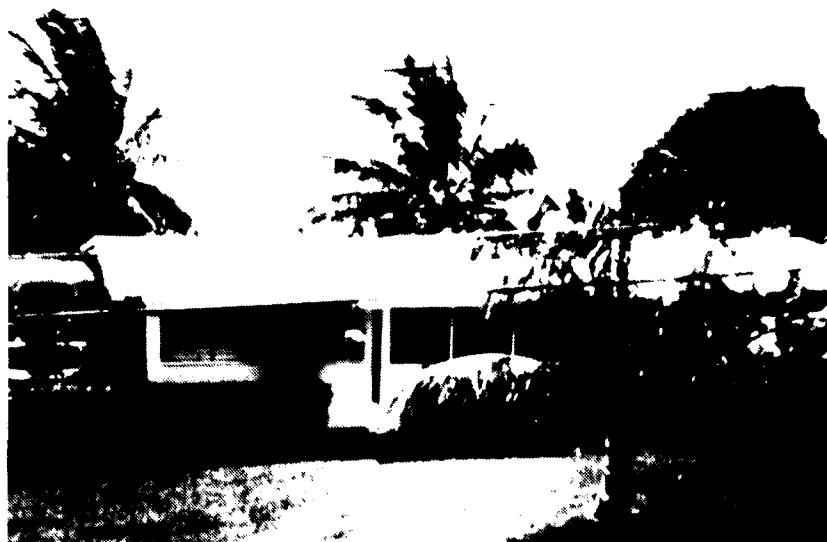
Figure 1 depicts a typical family housing unit included in the experiment. Roof decks are low-slope structural concrete in all cases. Houses are located in a semi-tropical environment near the sea shore with tropical landscaping - including numerous palm trees and dense shrubbery.

Figure 1. Typical experimental house with low slope concrete roof deck. Note tropical foliage, which is often dense, and roof mounted TV antenna. Naval Station, Roosevelt Roads, P.R.
